sample **PORTFOLIO**

Amy Aquilina

RIBA Part II Architectural Assistant

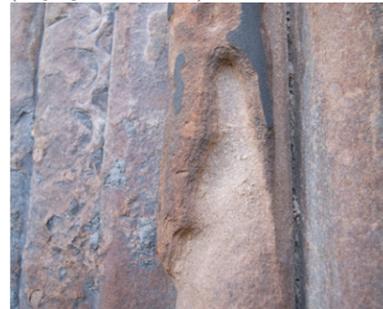
Visible migration of iron oxide and mineral cements to the outside face of the stone, leaving a powdery inner stone lacking cohesion.

The site is experiencing rapid erosion with visible deterioration from one year to the next. The decay is manifesting in different pathologies on the southern portion than in the northern portion of the facade. On the southern portion, which is exposed to the predominant wind and driving rain, the carvings have been eroded leaving smooth shapes and loss of detail. The North is more heavily affected by black crust due to its sheltered position. While the black crust has largely preserved the detail of the carvings it has different mechanical properties to that of the underlying stone causing it to break away in thick layers - exposing a very weak and crumbling stone with little cohesion. The advanced state of decay observed could be due to the incorrect bedding of the stone (it appears to be face bedded in many locations), exposure to the elements, its location in an area which has historically been industrial and so subject to acid rain, and finally the poor quality soft stone selected for the ease of carving into. Pooling water can be observed around the base of the structure where subsidence appears to be taking place. Chunks of stone are falling from the structure.

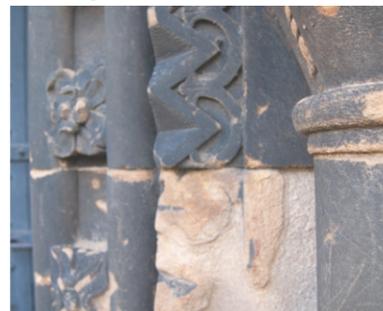
Loss of detail in areas where the black crust has come away from the stone.

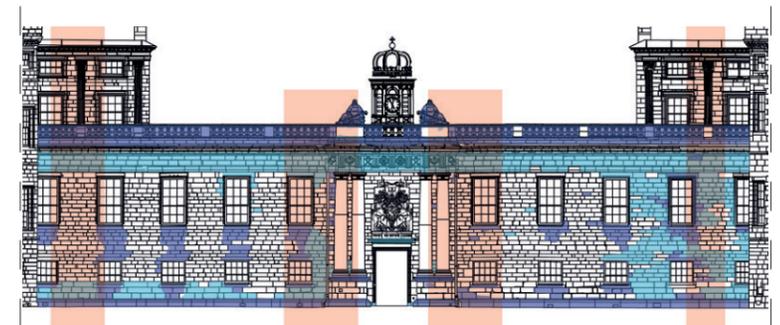
Water movement in the facade

Black crust —■—
Staining from water —■—
16th century turret locations —■—

Holyrood Palace base elevation supplied by HES, mapping by author

The façade faces the predominant wind direction and so is subject to driving rain. Historically Edinburgh suffered with smog and so acid rain would have also contributed to the deterioration of the stone. Aggressive acid cleaning of the façades and the courtyard took place in the 1970's, further accelerating the decay.

There is some speculation that the preceding west façade can be found behind the one we see today which may be causing some moisture retention issues in various areas of the façade, particularly around historic turret locations. Photographs reveal slight differential movement, potentially due to archaeology beneath areas of the façade. Recommendations were made for areas requiring further investigation, including the suitable tests that may be employed, noting statutory approval is required for destructive tests. Finally interventions were proposed to improve the condition of the façade and to address areas of concern. A maintenance plan was also proposed for preventative conservation moving forward.

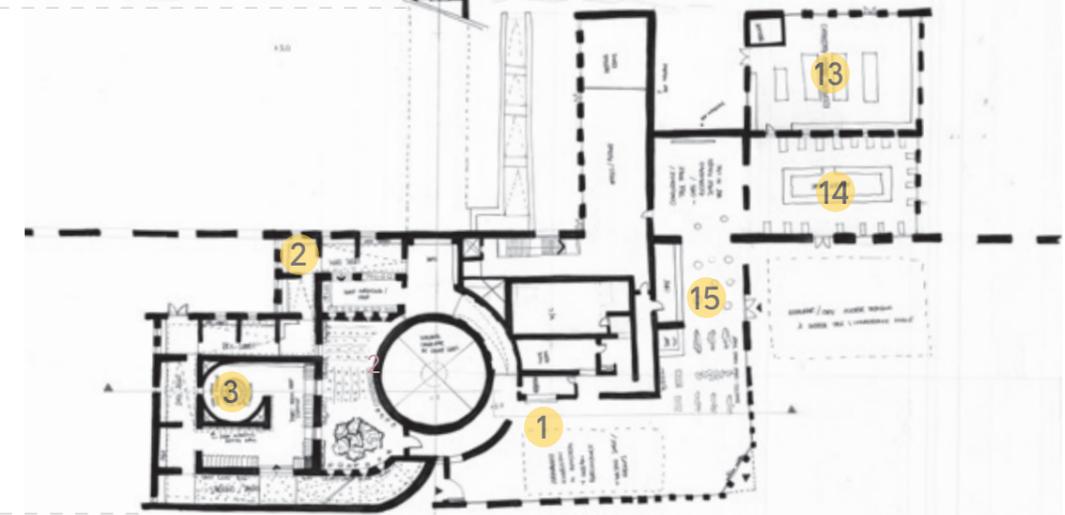
-01 underground level

1. entrance & route start
2. seed drying
3. seed storage
4. seasonal calendar
5. germination
6. seedlings
7. hardening off
8. indoor growing
9. garden growing
10. processing harvest (outwith plan)
11. preserving (outwith plan)
12. storage (outwith plan)
13. community kitchen
14. community food hall
15. community cafe
