THE MAIN REINFORCED CONCRETE STRUCTURE

PHOTOS OF INTERNAL & EXTERNAL DETERIORATION & STRUCTURAL CRACKS

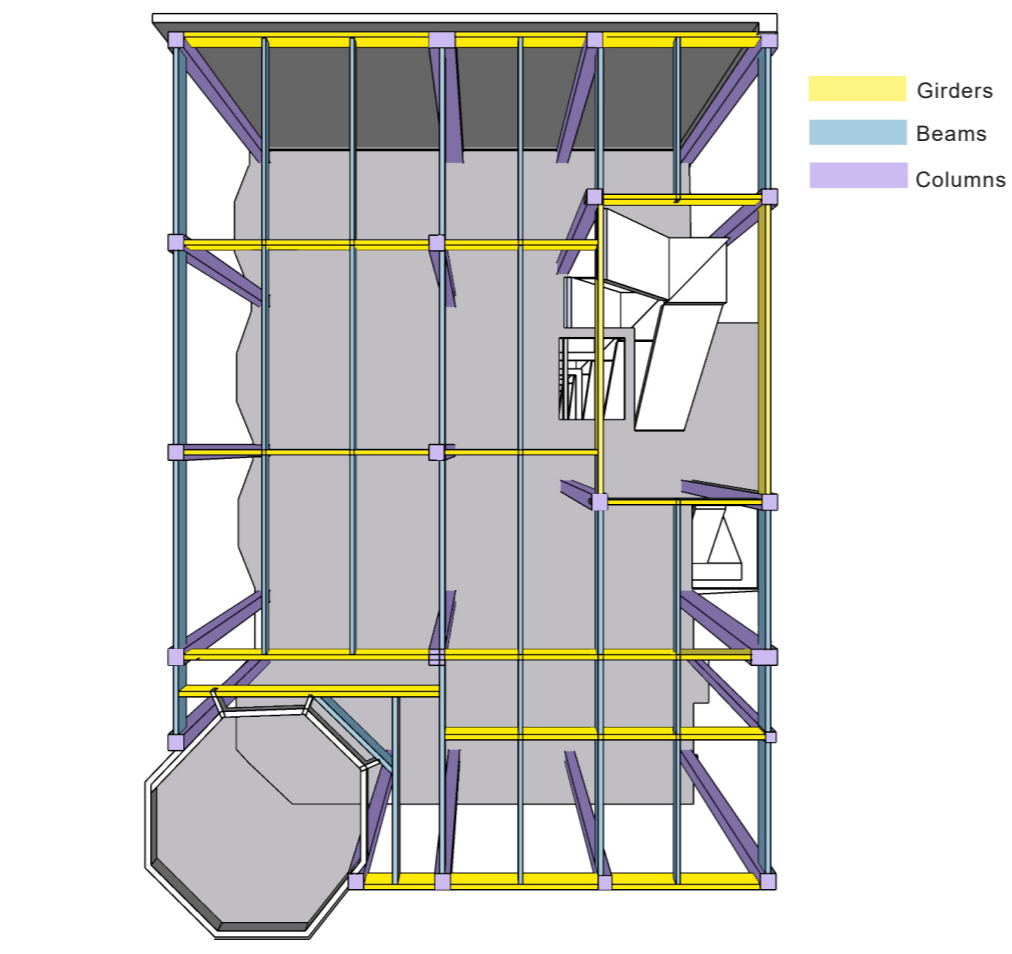
The plan shows the various structural components of the Lion Chambers. (Source: Pardee & amendments by author, 2021)

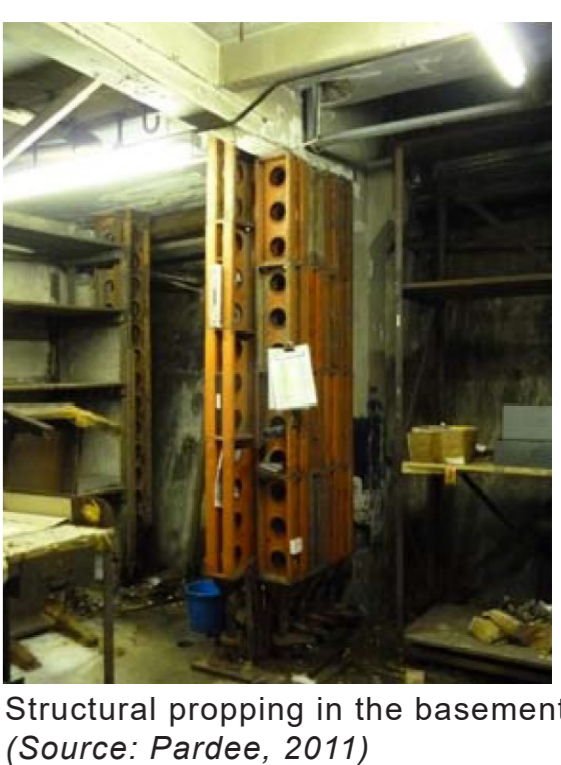
Additional structural propping in the basement was installed in 1998. (Dimitrijevic, 2011.) The environmental and conditions report by Curteis, 2015 shows pooling of water in the basement which unlikely is groundwater or foul drainage. The most likely cause is surface water drainage.

Structural propping in the basement (Source: Pardee, 2011)

However an additional new assessment and survey has to be undertaken to investigate the foundations/columns.

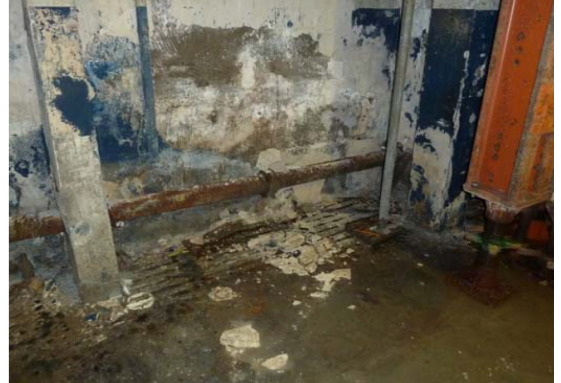
There may be poor detailing which is also leading to water ingress inside the basement, lack of any water proofing or insulation and the fact that the building is also situated along a hill/ steep slope, which easily brings down surface water towards the building.

Water damage and condensation issues to the basement. (Source: Curteis, Preliminary assessment of the environmental conditions associated with the conservation and redevelopment of the lion chambers, Glasgow. June 2015.

Possible intervention: Full replacement of the basement (raft slab, footings, retaining walls). New tanking, waterproofing and insulation. The foundations need to be investigated by a structural engineer.
